SAYANO-SHUSHENSKAYA

Southwestern Federal Hydropower
Conference
Branson, Missouri

Russian Hydropower Accident

Sayano-Shushenskaya Unit 2 Failure

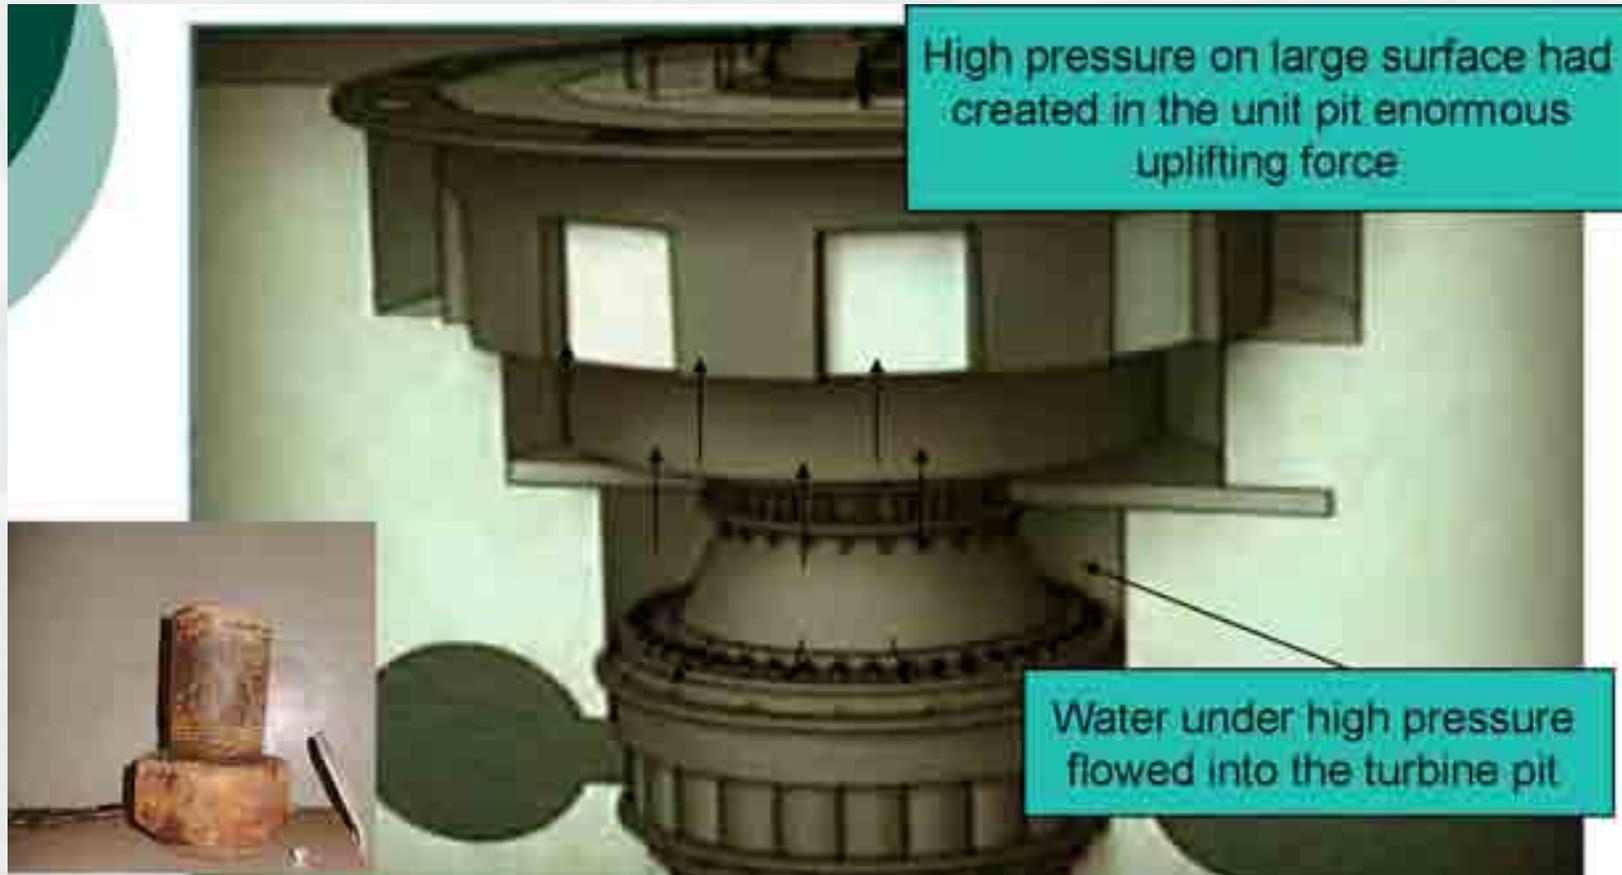
Turbine Unit

The net result is the unit was ejected from the turbine pit...

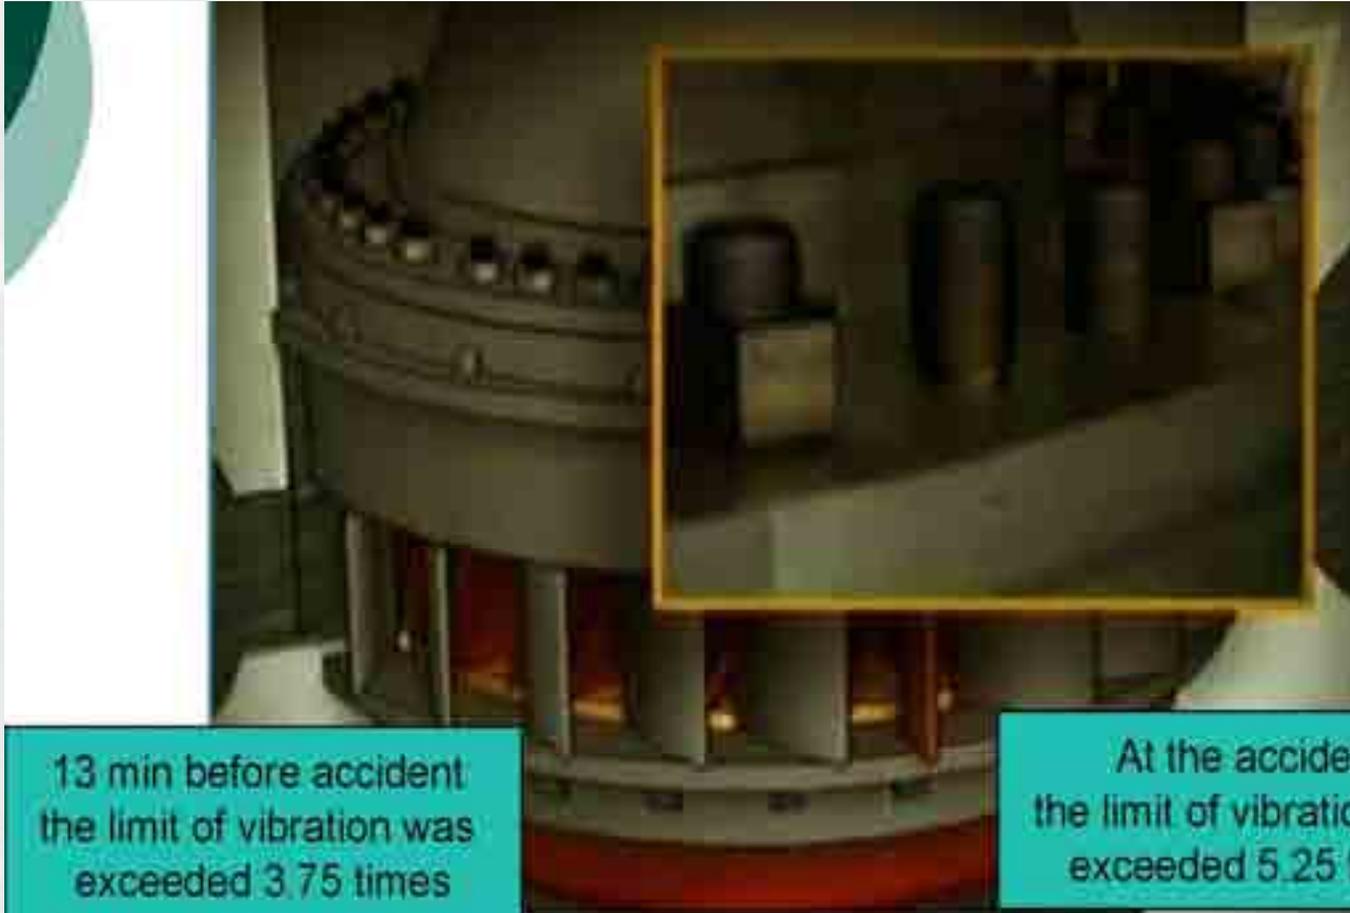
The Head Cover Studs Failed

13 min before accident
the limit of vibration was
exceeded 3.75 times

At the accident
the limit of vibration was
exceeded 5.25 times

- The accident was primarily caused by the head cover studs failing.
 - **80 studs held the head cover down.**
 - **41 studs had fatigue cracks**
 - **2 studs were destroyed by tension**
 - **6 studs completely undamaged, leading to the conclusion that no nuts were present.**
- Average fatigue damaged area exceeded 65% of the total stud cross section.
- The cause of the failure is still being debated. Leading candidates are unit vibration, load rejection, or governor failure.

- Inspect all turbine head cover studs and nuts.
- Verify that the emergency closure systems function at all plants and test the emergency closure gates under full unit flow.
- Verify all governor shut down and timing (wicket gate closure speeds).
- Review Emergency Plans and Procedures
- Maintain Staff Competency
- Inspect turbine runners for cracks.

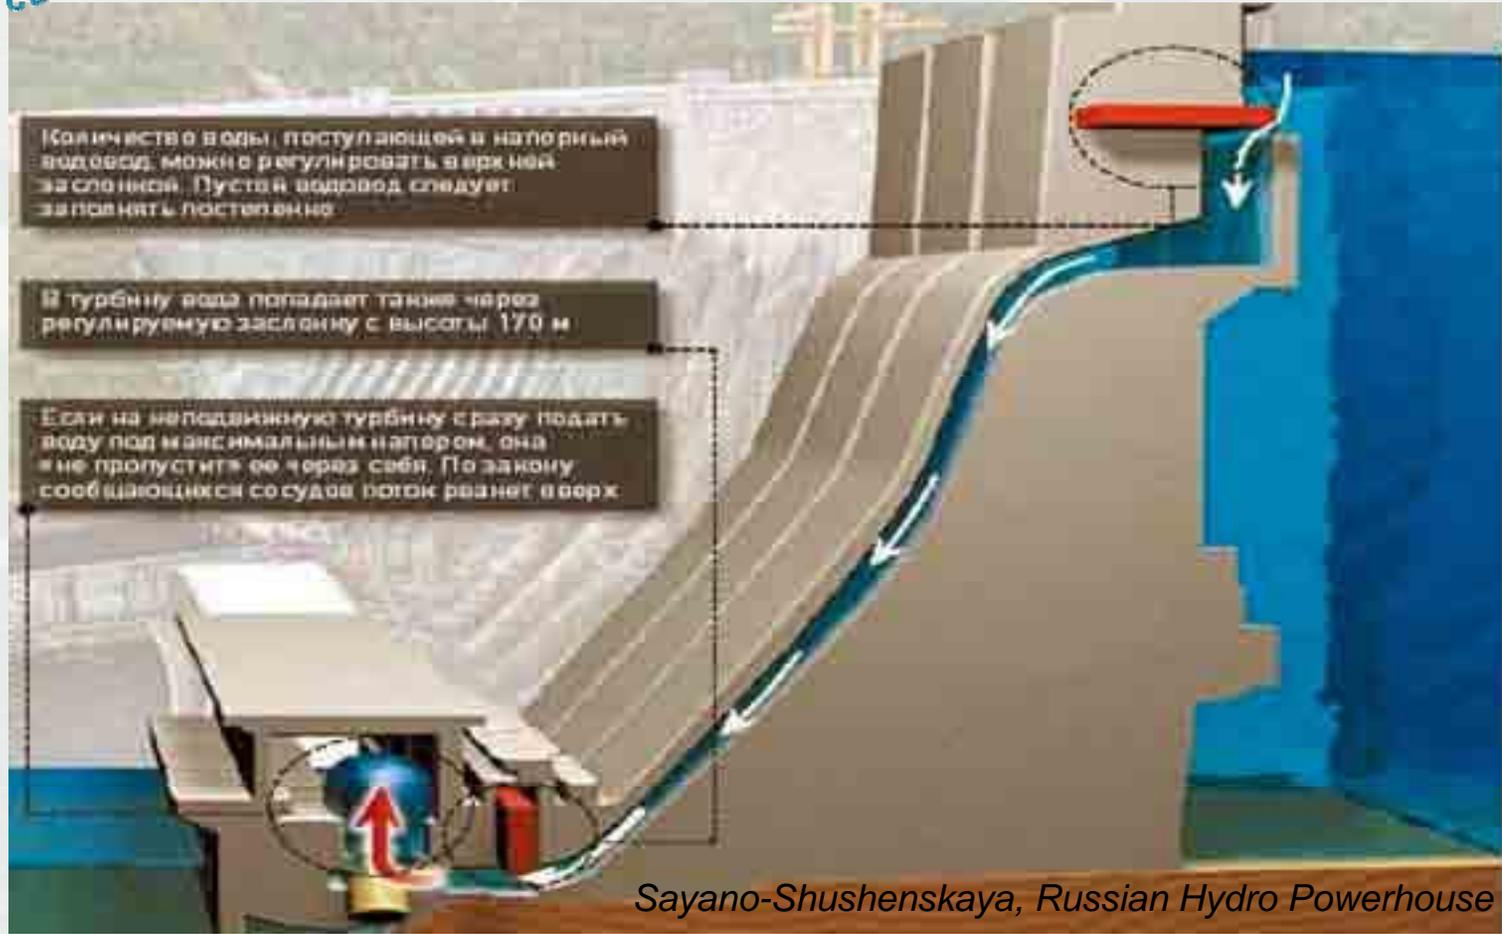
The unit weighs 2960 tons (US) and the rotor weight is 995 tons (US).

There are reports that the Unit was ejected vertically 3 meter's (about 10 feet).....

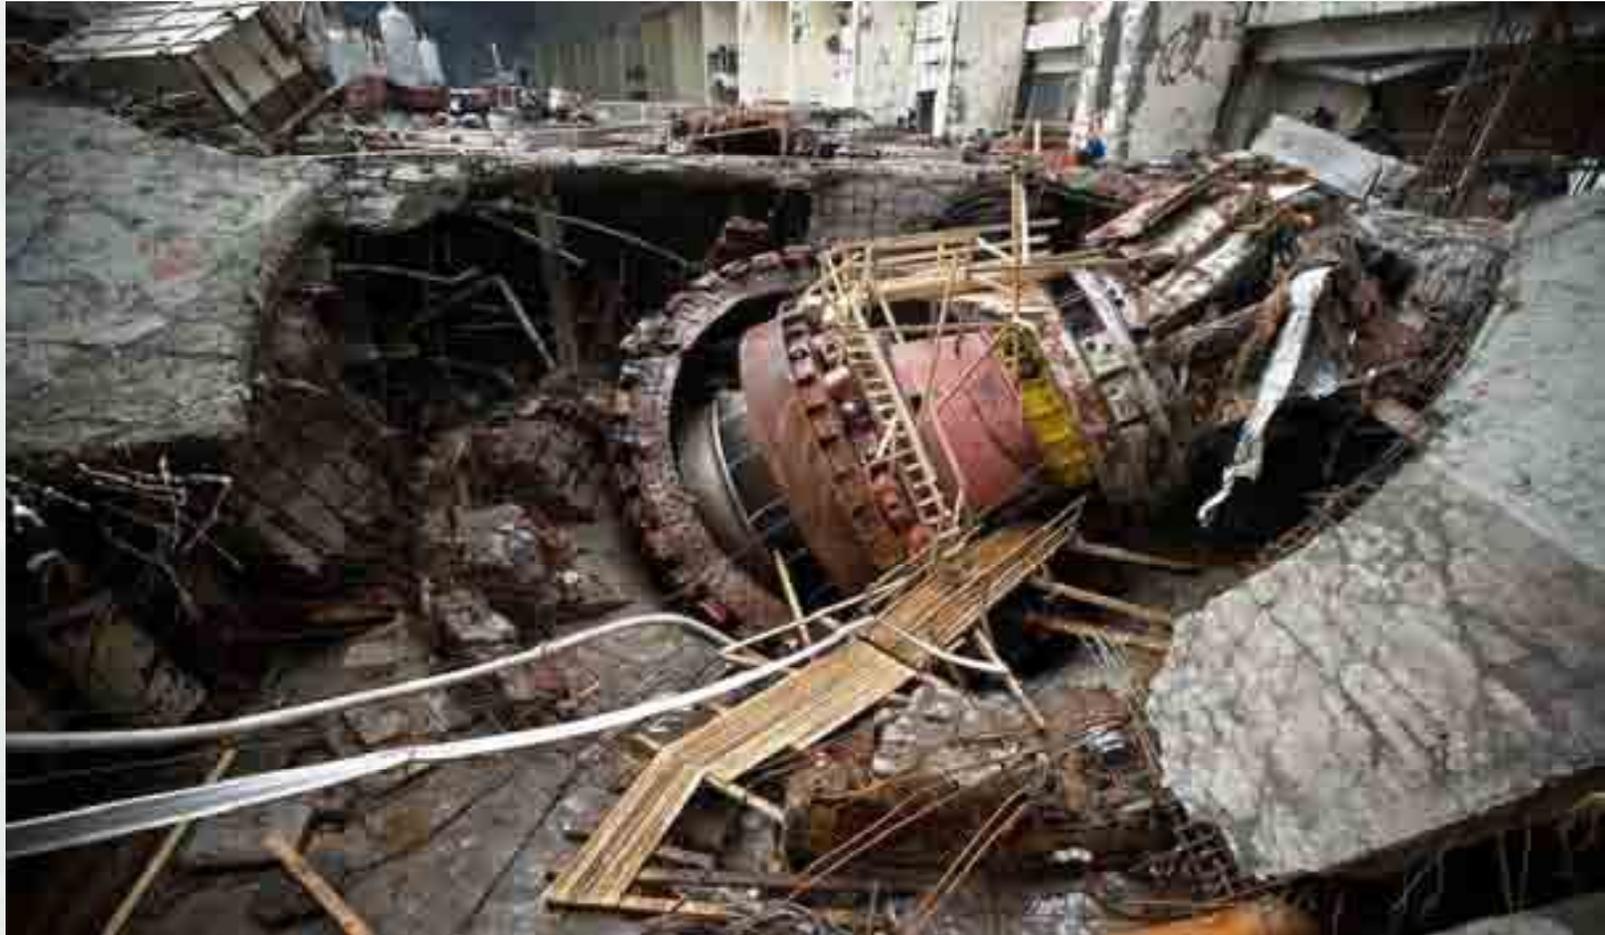
....resulting in this.
