Webbers Falls and Ozark Powerhouse Major Rehabilitation

**Briefing for 2012 Southwestern Federal
Hydropower Conference**

Lee Beverly - Project Manager
Little Rock District

13 June 2011

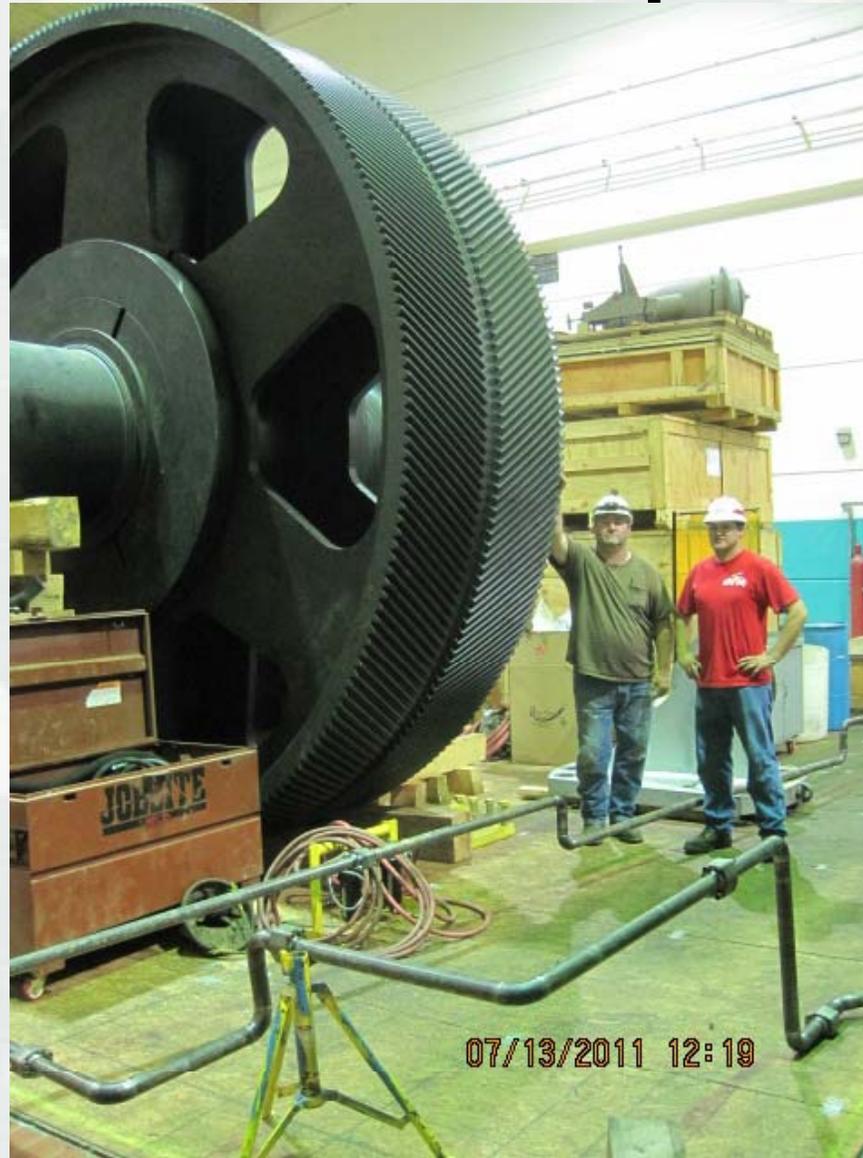
Ozark Unit 5 Low Speed Gear

2 inch section of low speed pinion gear tooth found missing.

Inspection showed cracks in teeth on both pinions.

Transfer new Ozark unit 5 gear and pinions to Webbers.

Ozark unit 5 gears will be re-evaluated for replacement.

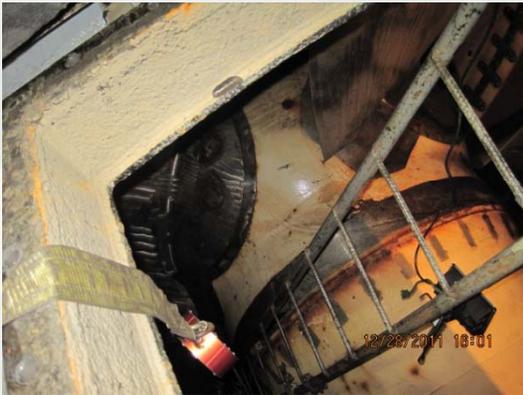
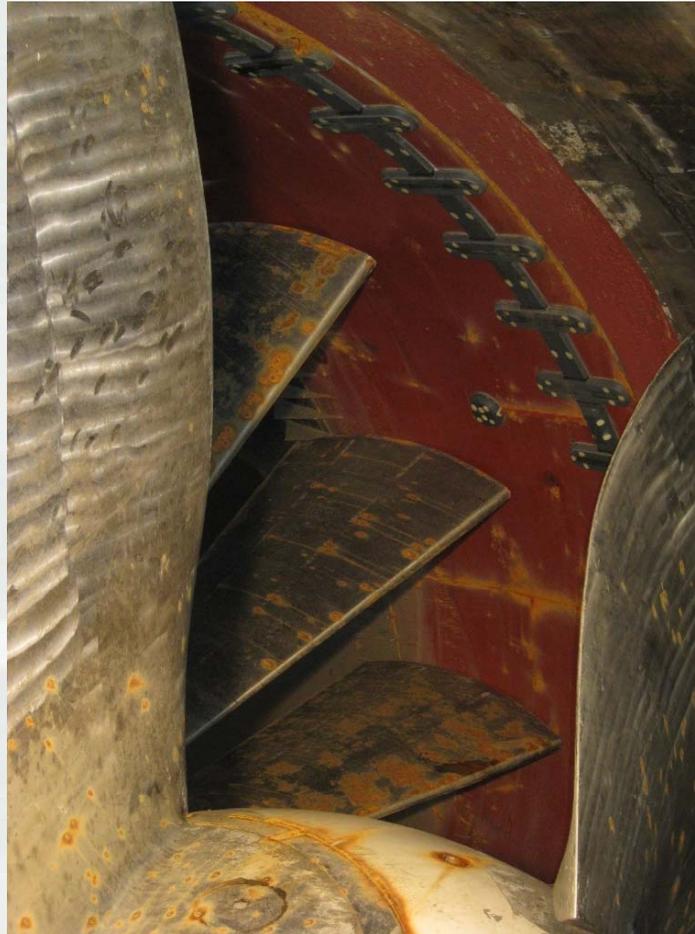
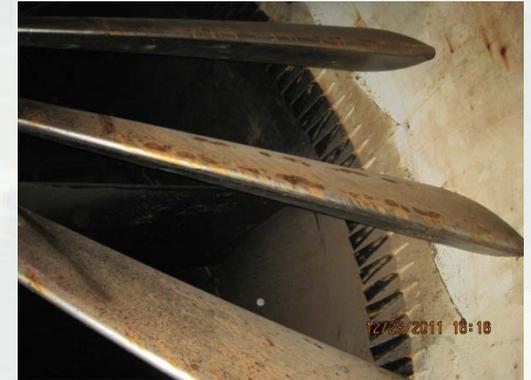
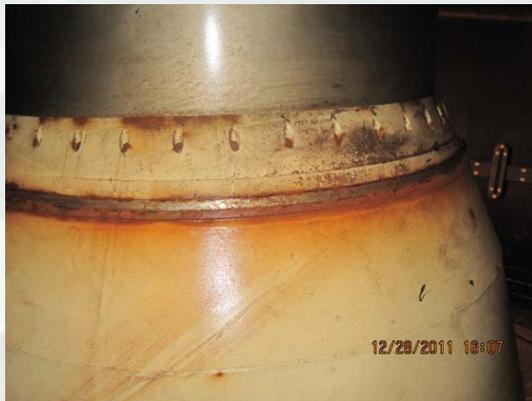
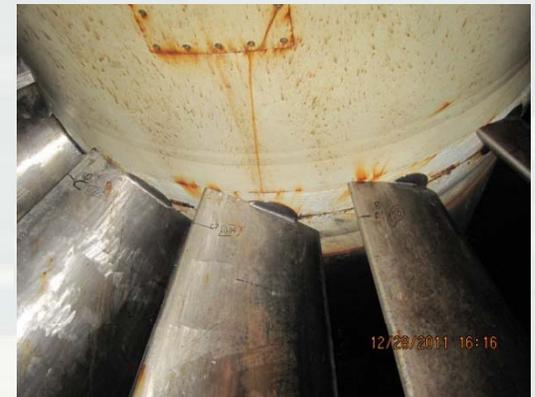
Corrosion of New Units

Problem: Significant corrosion occurred on Ozark Unit 4 and Webbers Unit 3 prior to startup. Wicket gates were pitted, turbine blades had minor pitting.

Solution: Weld up pits in wicket gates. Passivate all stainless steel in place.

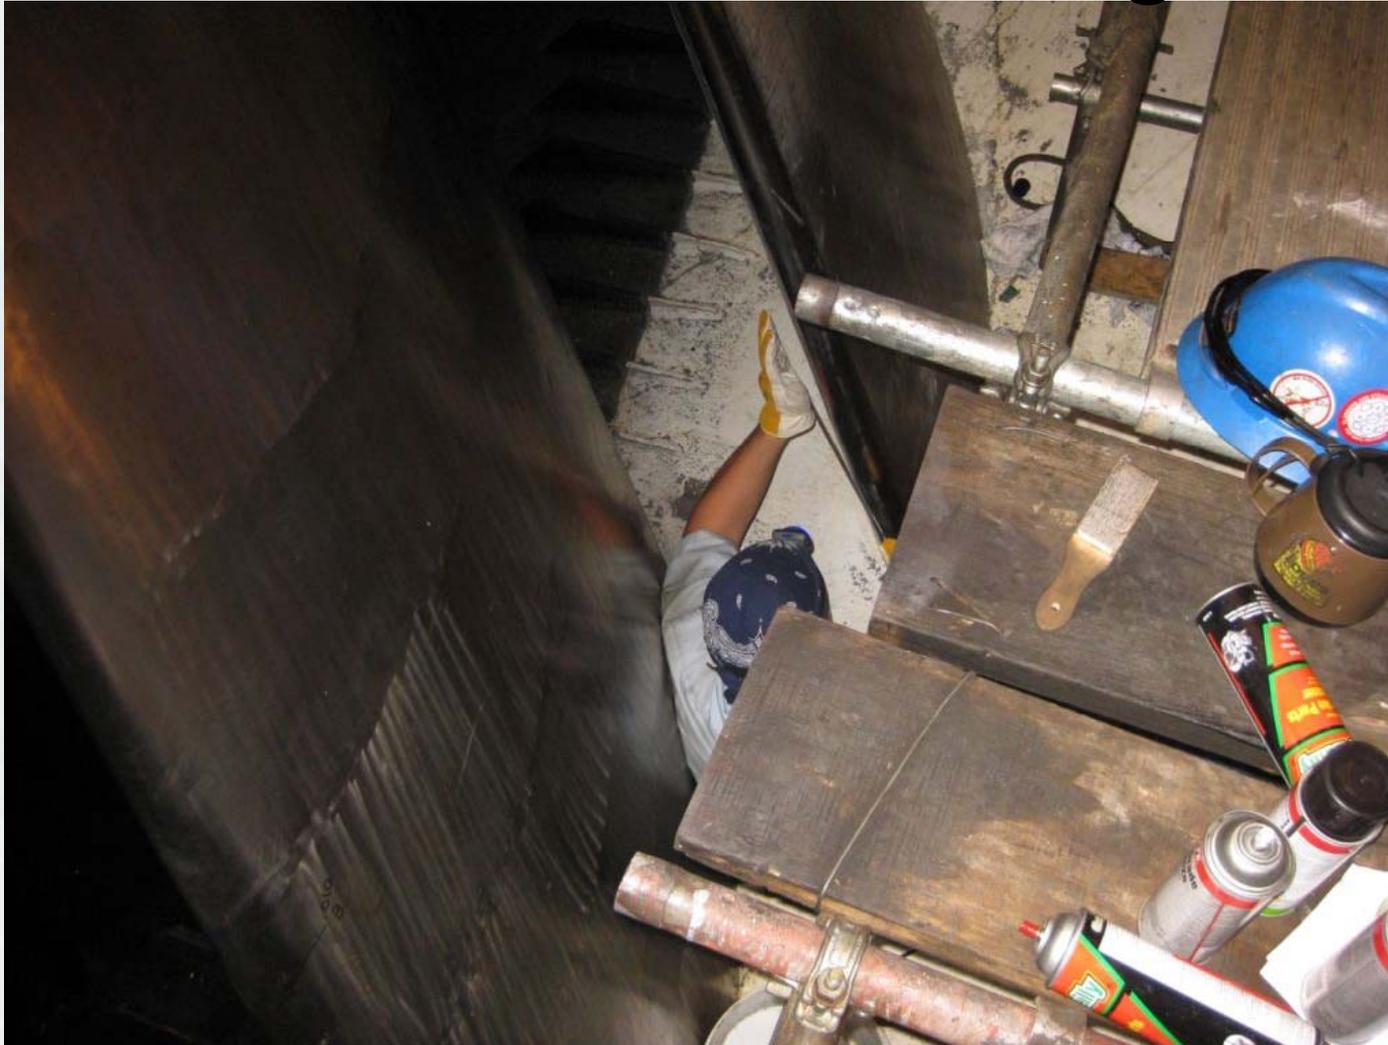
Wicket Gate Re-filing

Problem: During the weld repairs of corrosion damage, the wicket gates warped as a result of the heat from the welding.

Solution: The gates required re-filing to meet closure tolerances
