Stockton Power Plant Major Equipment Repair and Replacement

Southwestern Federal Hydropower Conference
Branson, MO

Robin Wankum
Project Manager
Kansas City District
9 June 2010

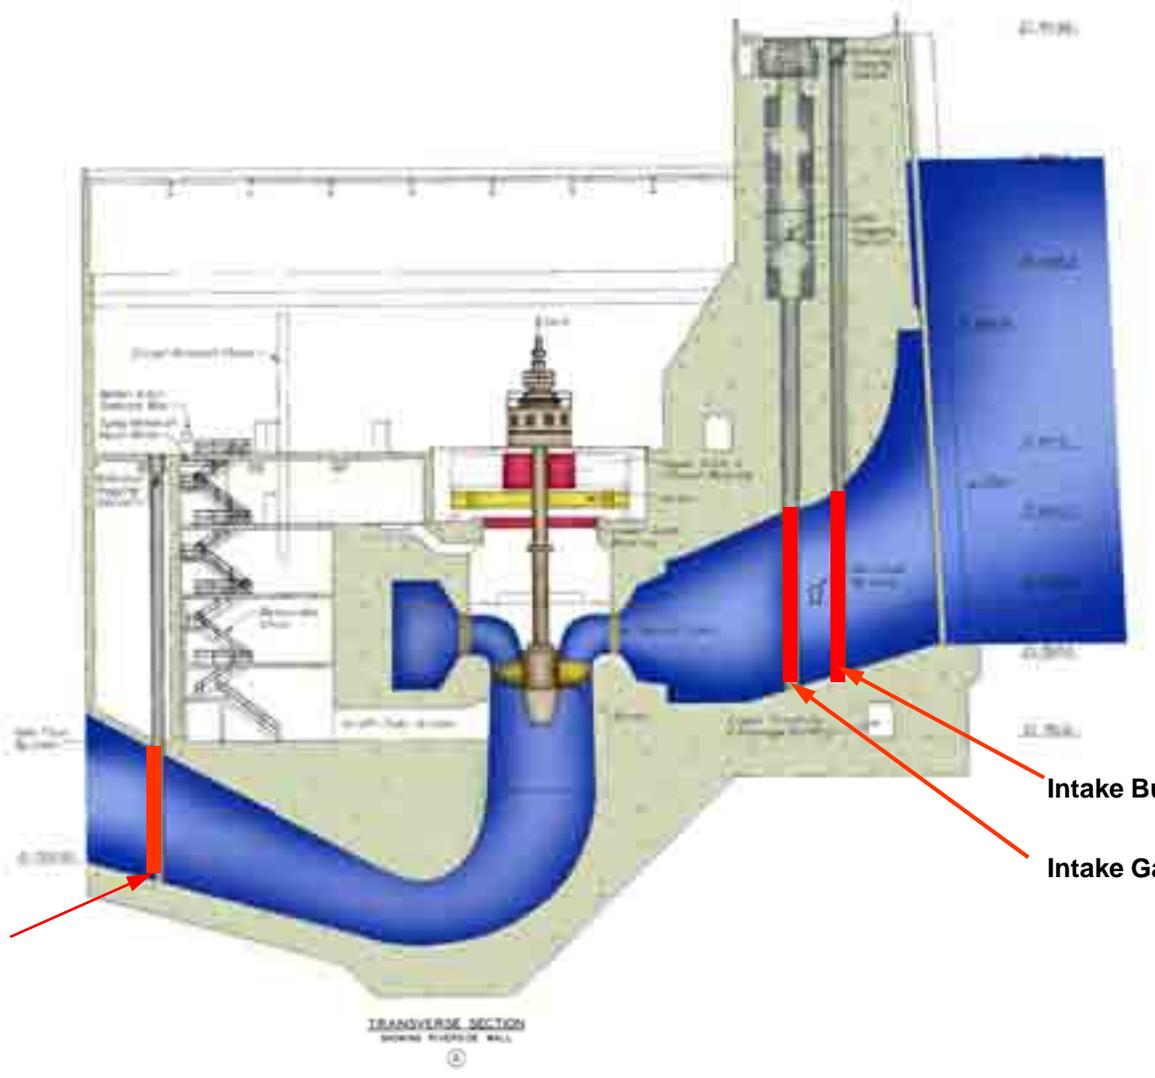
Power Plant Cross Section

Draft Tube Bulkheads

Intake Bulkheads

Intake Gates

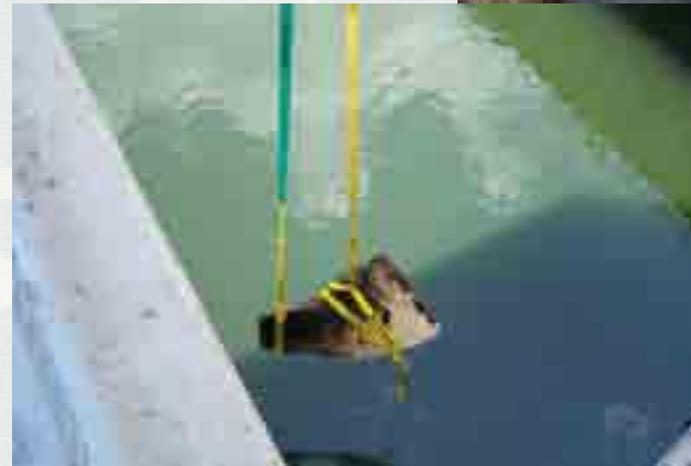
- On 4 Feb 2009 the unit experienced a severe vibration activating vibration alarms
- Cyclic pulsations and water leakage at the draft tube hatch door were observed
- Unit was shut down immediately
- Failed blade section was discovered by divers at the bottom of the draft tube
- Partial dewatering was performed to inspect turbine runner
- Turbine blade #4 experienced a catastrophic failure
- Potential cracks were also observed on three of the other five blades (blades #2, #5, and #6)
- Failed blade section was recovered by divers in August 2009

- Contract Awarded: 15 May 10
- Contract Amount: \$1,352,250
- Contractor: Peak Hydro
- Schedule
 - ▶ Preparation/NDE of failed blade section: 9 – 29 Jun 10
 - ▶ Preparation of runner hub & NDE of other blades: 17 Jun – 12 Jul 10
 - ▶ Weld repair of cracks and failed blade section: 13 Jul – 24 Aug 10
 - ▶ NDE weld repairs: 25 – 31 Aug 10
 - ▶ Site cleanup and demob: 1 – 8 Sep 10
 - ▶ Water up unit for test run: 9 Sep 10
 - ▶ Submit final report/work documentation: 13 Sep 10
 - ▶ Contract Complete: 13 Sep 10

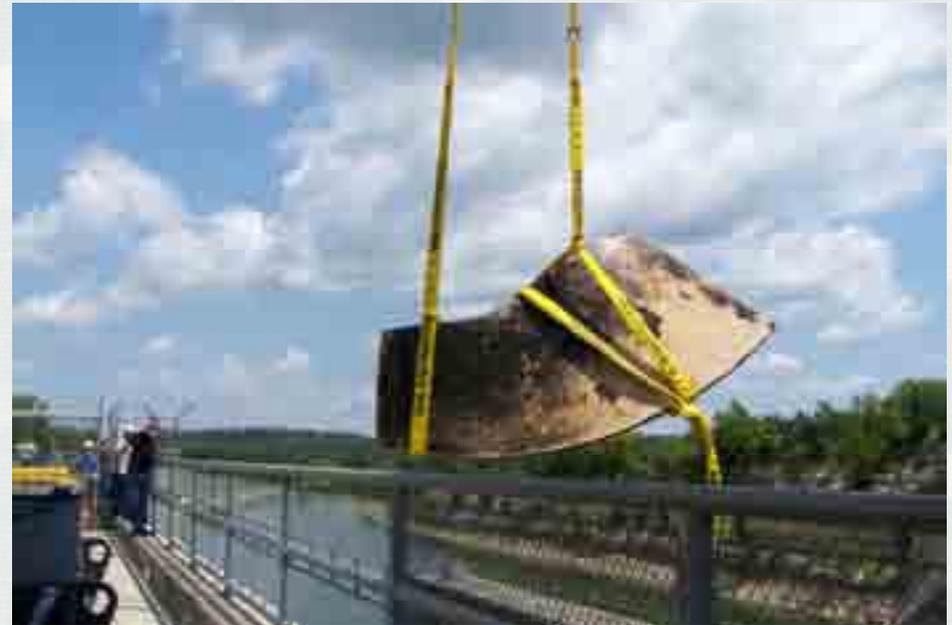
Blade Recovery

- Contract Awarded: June 09
- Contractor: Mainstream Commercial Divers, Inc.
- Contract Completion: August 09
- Total Contract Costs: \$69,487

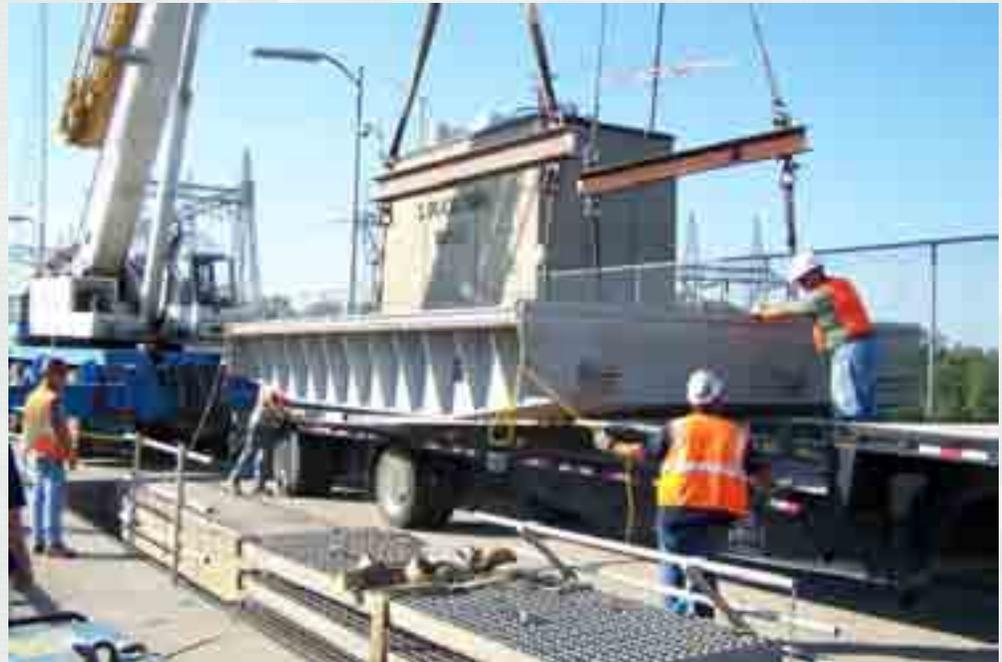
Hydraulic Steel Structure Repairs

- Contract Awarded: July 09
- Contractor: OCCI, Inc.
- Contract Completion: April 10
- Summary Weld Repair
 - ▶ Draft Tube Bulkheads - 61 cubic inches on all 3 bulkheads
 - ▶ Intake Bulkheads - 45 cubic inches on all 3 bulkheads
 - ▶ Intake Gates - 385 cubic inches on all 3 gates
- Other Work
 - ▶ Replacement of anodes on intake gates
 - ▶ Replacement of seals on intake and draft tube bulkheads
- Total Contract Costs: \$1,156,834
