Projects Impacting Federal Power Kansas City District

Southwestern Federal Hydropower Conference
Hot Springs, AR

Harry S. Truman Power Plant

Unit 6 Main Shaft Coupling Stud Failure

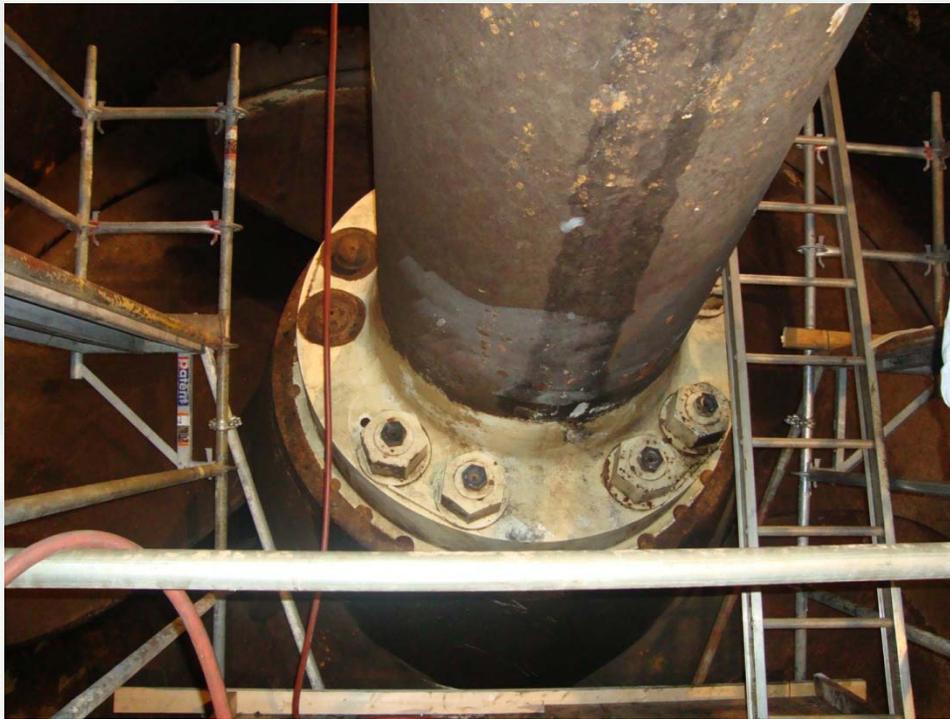
- ▶ Aug 2011 unit experienced a significant oil spill after operating the unit to flush the draft tube.
- ▶ Unit was dewatered and visual inspection revealed oil leakage around the main shaft coupling nut covers.
- ▶ Plant staff removed the nut covers and discovered two failed coupling studs.
- ▶ Unit has recorded approx. 47,000 hours of runtime since being overhauled and placed back into service in 1993.

Failed Studs 8 & 9

- Unit 6 Repair
 - ▶ Replace all main shaft coupling studs with new rolled thread design
 - ▶ Replace stub shaft coupling studs if inspection reveals damage
 - ▶ Secure the dowel pin
 - ▶ Upgrade vibration monitoring system
 - ▶ Return unit to service with increased monitoring and inspections
 - ▶ Goal is to have all repairs completed and unit back in service by Dec 2012
 - ▶ Estimated repair cost is \$250K

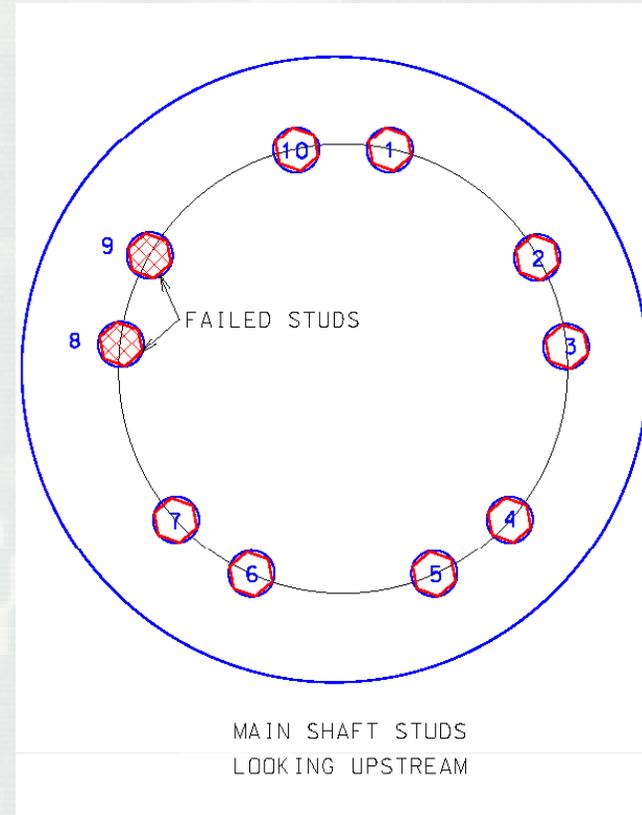
Main Shaft Studs Layout

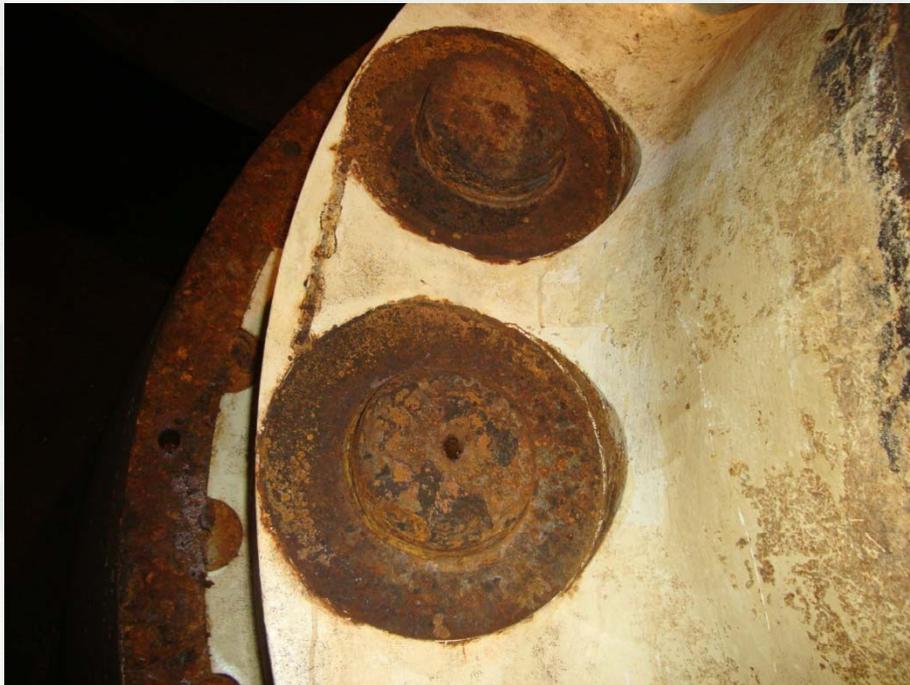
Failed Studs 8 & 9

- Investigation/Analysis – Completed Activities
 - ▶ Removed broken studs.
 - ▶ Measured adjacent stud lengths (#7 & #10). Measurements indicate studs are stressed/damaged.
 - ▶ Pressure tested hub at 40 psi. Test indicated O-ring seal is ok.
 - ▶ Inspected main shaft flange for cracks. No cracks were found.
 - ▶ Removed stud #4 to check for corrosion, cracks, damage. Stud, washer, and nut were in satisfactory condition with minimal corrosion.

- Investigation/Analysis/Repair – Ongoing/Future
 - ▶ Procure scaffolding and inspect stub shaft coupling studs and flange. Scaffolding contract has been advertised and awaiting award.
 - ▶ Procure main shaft and stub shaft coupling studs. Contract will be advertised/awarded this Summer.
 - ▶ Procure AE services for measuring runner hub threads and completing failure analysis on broken studs (8 & 9) to confirm cause of failure. Contract will be advertised/awarded this Summer.

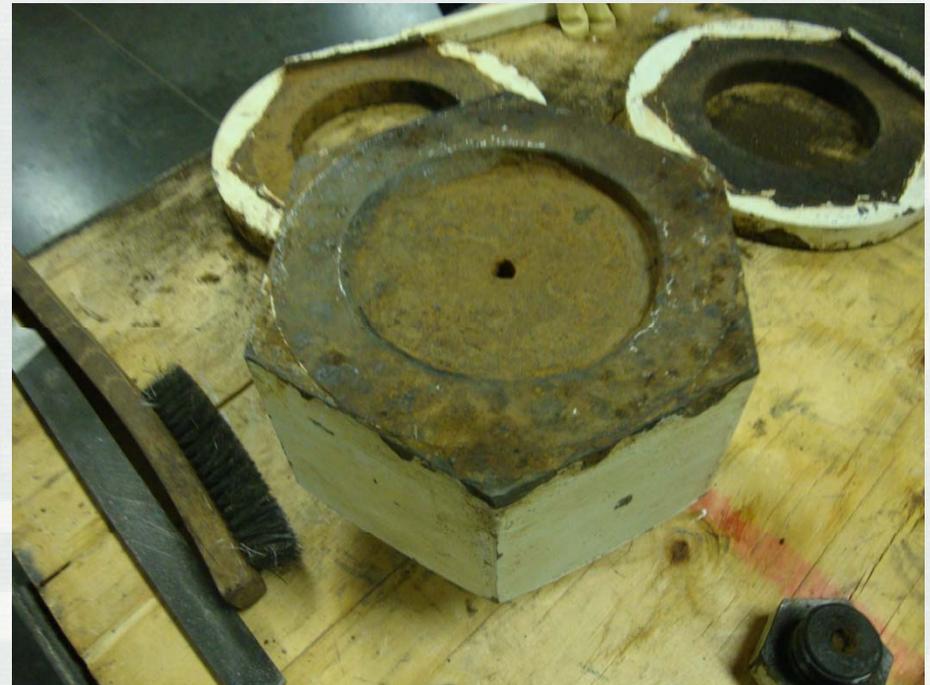
Nut and Washers

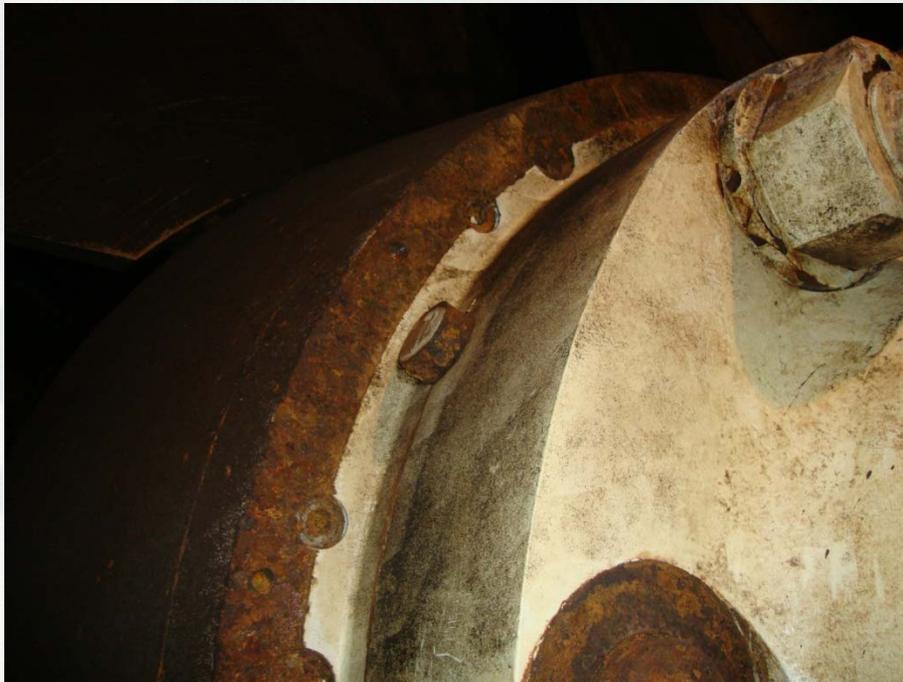
Mainshaft/Adapter Plate
Dowel Pin

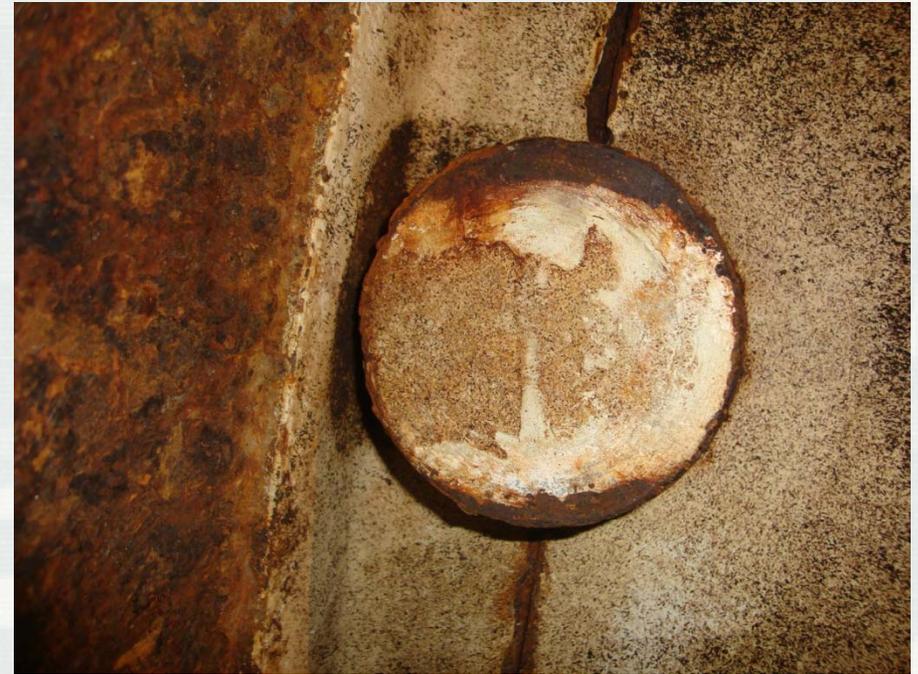
Dowel Pin (protruding out
approx 1 1/2 "

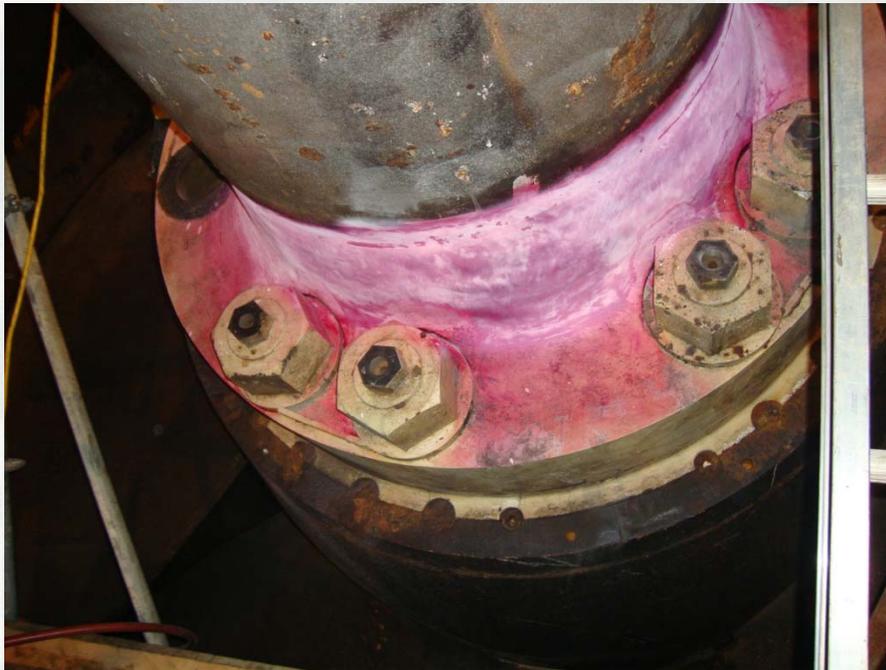
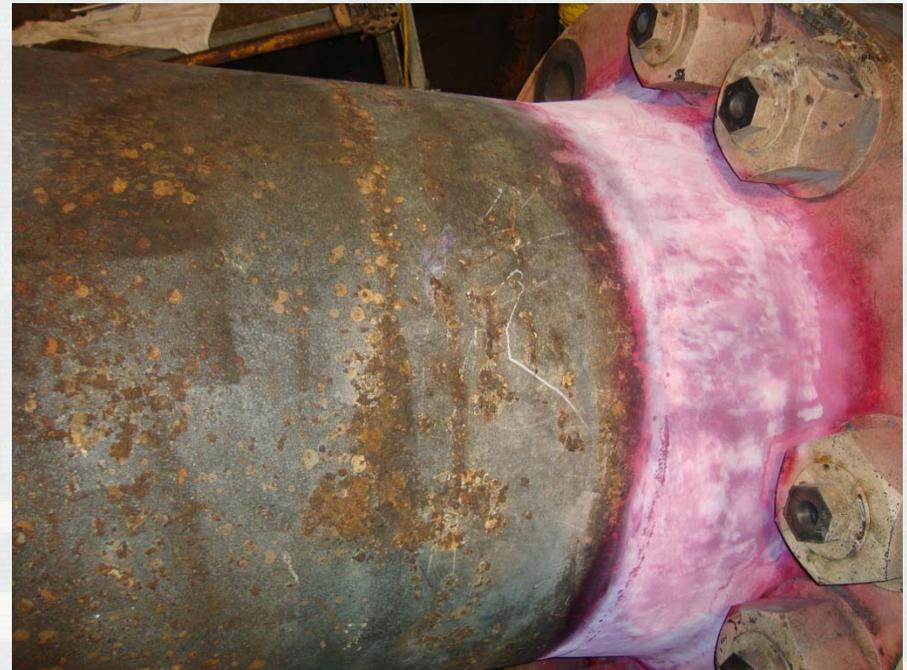
Mainshaft Flange Inspection
