Webbers Falls and Ozark Powerhouse Major Rehabilitation

**Briefing for 2012 Southwestern Federal
Hydropower Conference**

Lee Beverly - Project Manager
Little Rock District

13 June 2011

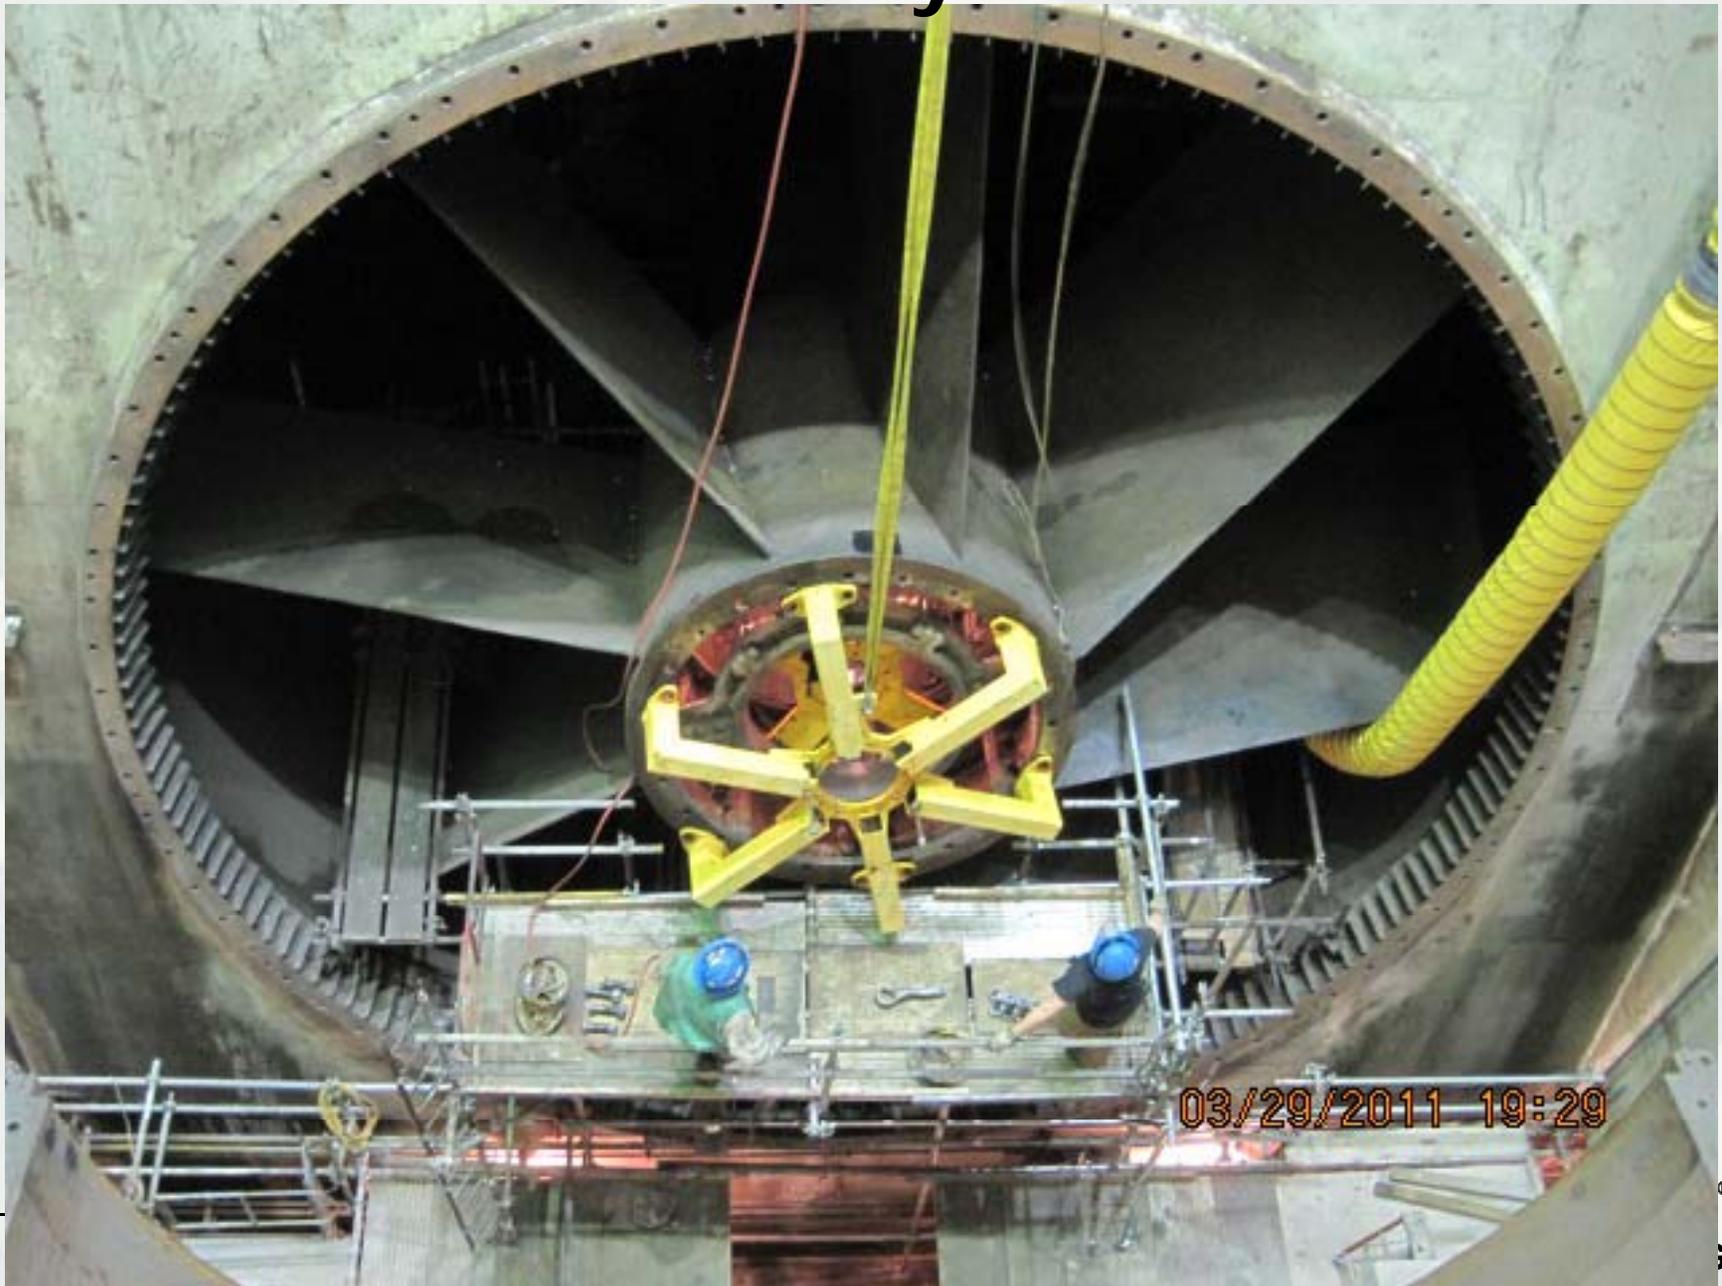
Unit Stay Vanes

- Gate slot blockage/unit unwatering
- Unit 4 Stay Vane Crack
- Unit 2 Upper Main Shaft Crack
- Unit 4 Corrosion/Weld Repairs
