PRELIMINARY

FY 2012

**NON-ROUTINE
MAINTENANCE
LIST**

May 25, 2010

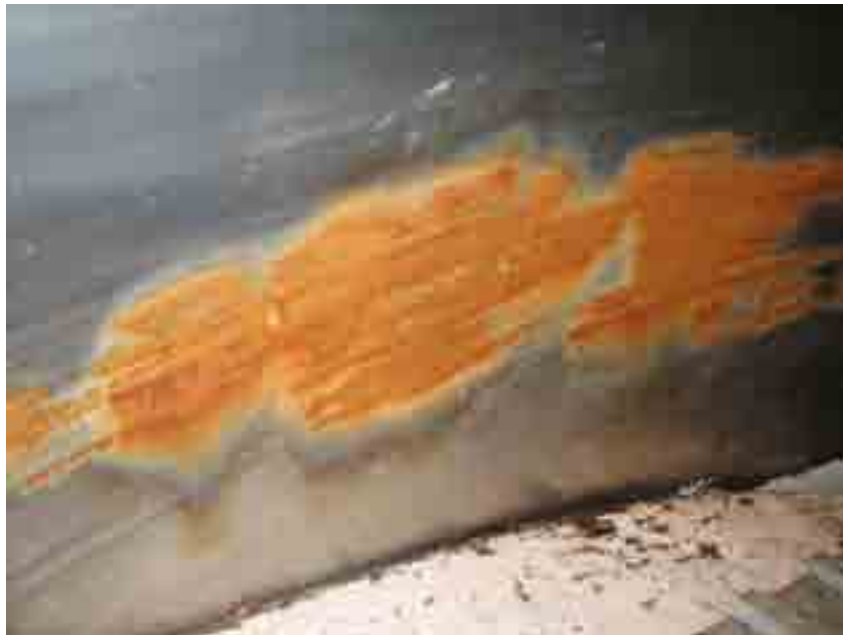
Picture of Turbine Blade Scrape with Liner
Notice White-Blue Area on Stainless Steel Liner due to Heat

History of Outages/Deficiency: The anchorage which hold back the stainless steel plates of the draft tube liner are failing. The Government has been making spot repairs as the problems have been found. The turbine's blades have struck the stainless steel draft tube liners in several places. This condition has increased maintenance and inspection activities as well as resulted in forced outages. Additional significant damage to blade trunion bushings, loss of turbine blades, turbine shaft coupling bolts could cost millions and require a long term outages to effectuate replacements that include turbine blades, hubs, and shafts.

Solution: Repair and replace damage draft tube liner panels. Re-anchor panels into embedded steel structural stiffeners in concrete scroll case structure.

Summary of Funding Argument(s): The draft tube liner is coming in contact and scrapping the turbine blades resulting in forced outages and significant amount of increased maintenance. Additional significant damage to blade trunion bushings, loss of turbine blades, turbine shaft coupling bolts could cost millions and require a long term outage including replacement of the entire turbine blades, hub, shafts.

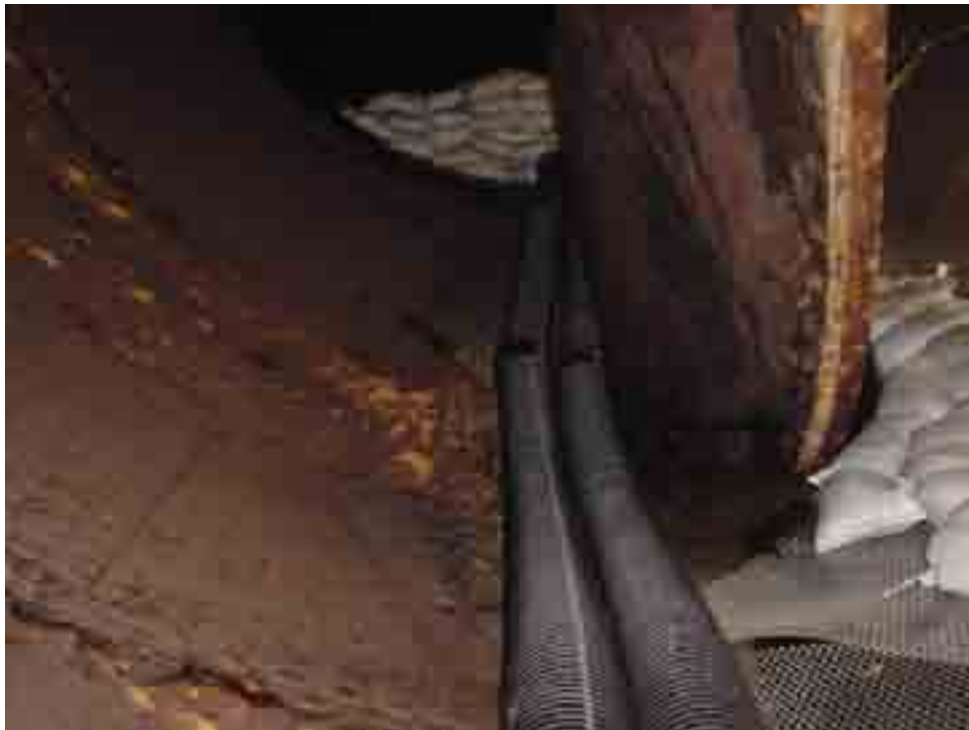
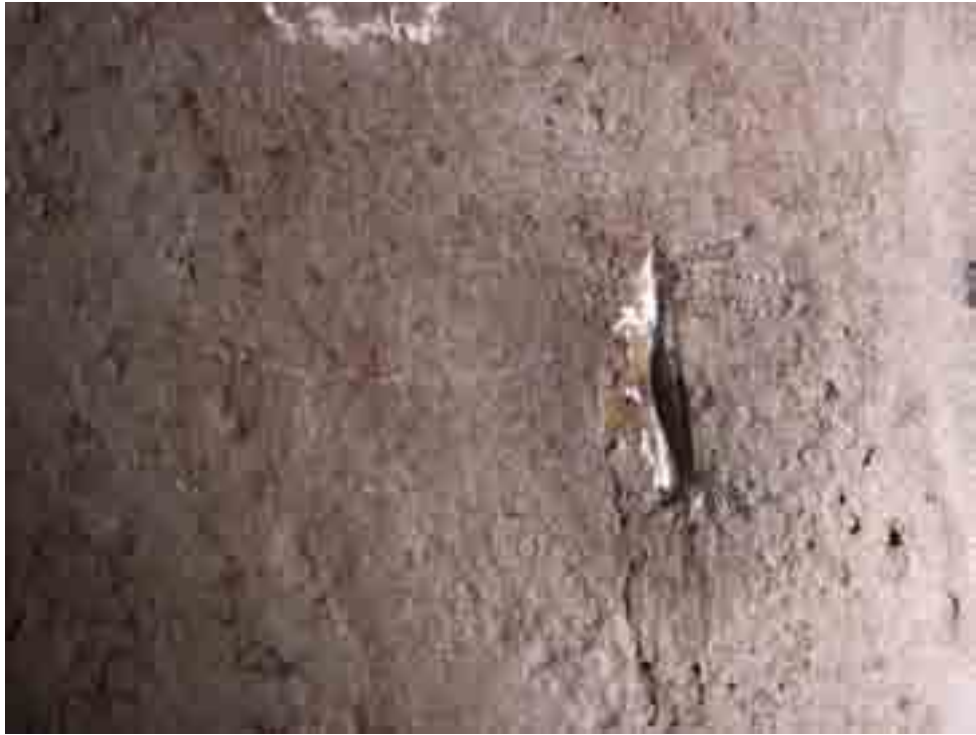
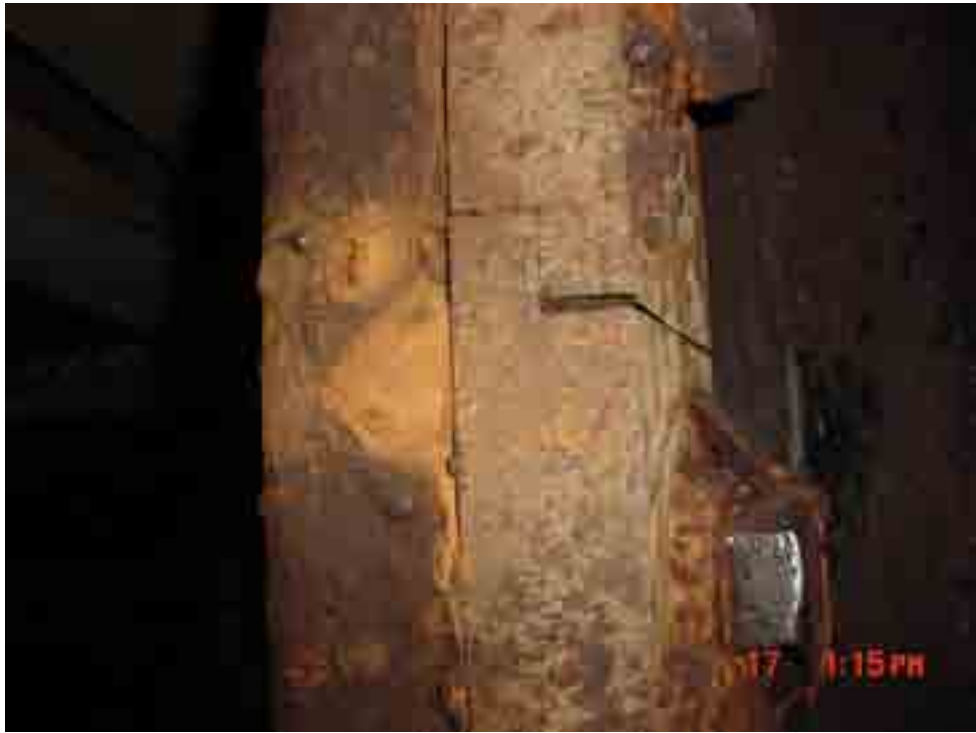
History of Outages/Deficiency: The power plant is 54 years old and the power tunnel has never been repainted and the tar based material has deteriorated and is beginning to peel off. The Butterfly valves have been inspected through the HSS program and recommendations have been made for repairs needed so work can occur behind the valves.

Solution: Repaint the inside and outside of the power tunnel and make repairs to the Butterfly valves.

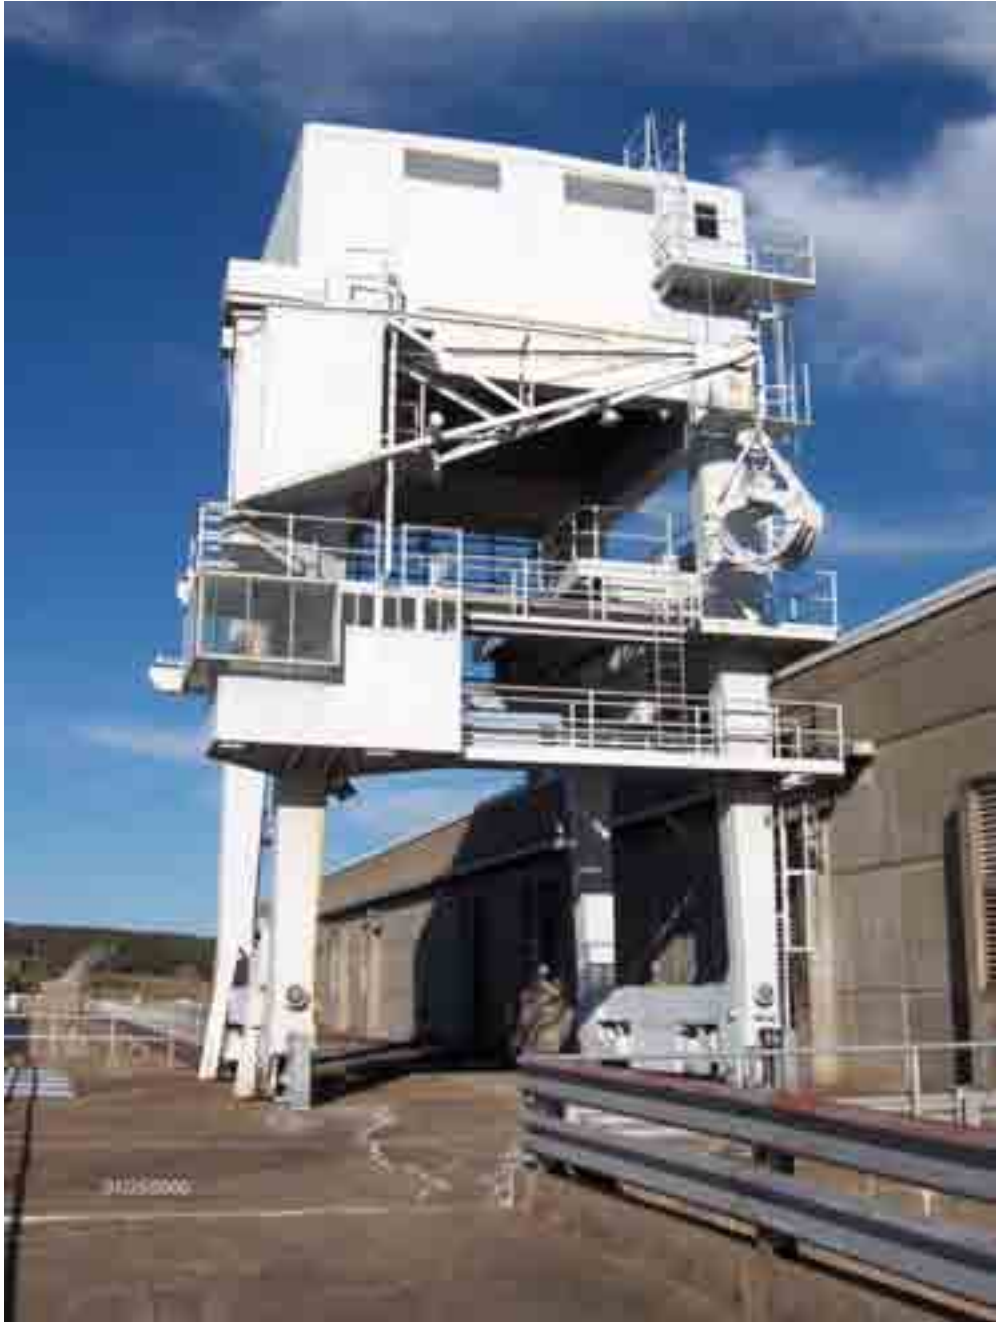
History of Outages/Deficiency Cranes are the original cranes and are 45 years old. The cranes are breaking down and need new wire rope, gears, and intake crane lifting beam (existing beam is bent). Additionally, asbestos and lead based paint abatement is needed. Crane controls are deteriorating and need replacement as well. Intake crane cab windows are glazed over which prevents proper viewing of operations. Little Rock received 2.5 million in O&M funding in FY10; however, this funding will not complete the rehabilitation of the cranes. The draft tube crane is getting minimal retrofit and a engineered lift is required when the crane is operated. Continued deterioration of the cranes will affect the ability to take the unit out of service.

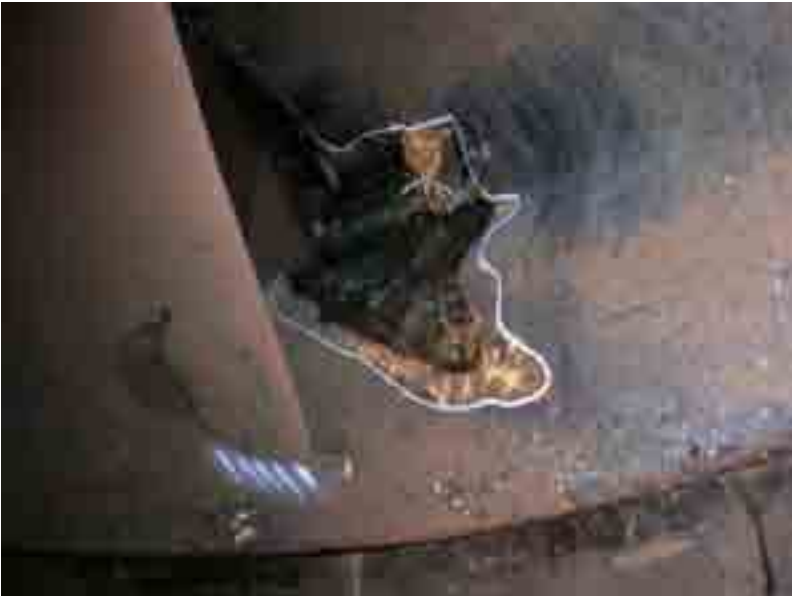
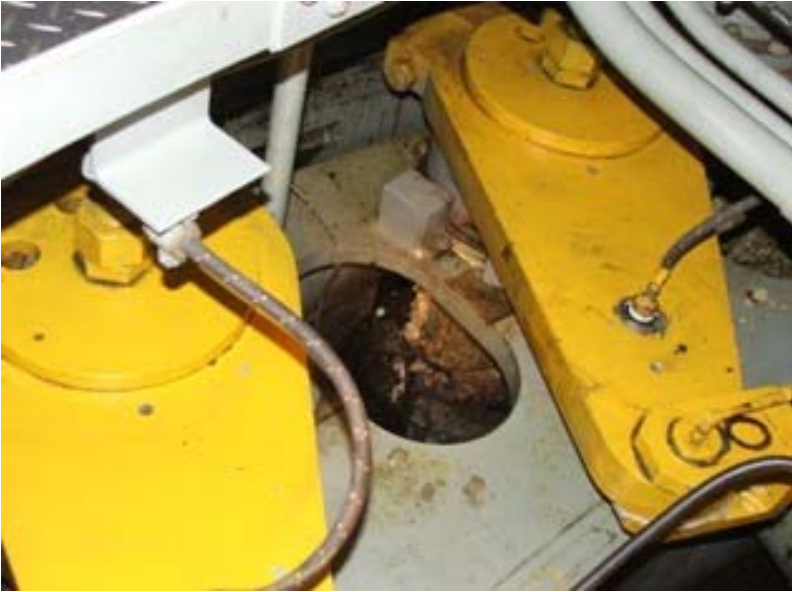
History of Outages/Deficiency: Cavitation damage was mapped and repairs were made by contract in October, 1992. The contractor repaired approximately 22,000 square inches of cavitation damage to the runner and discharge ring. In October, 2009, Hydro Consulting & Maintenance Service, Inc reviewed and evaluated the cavitation damage existing on the runner. Cavitation damage has occurred on each of the high pressure side of the blades. The deepest area of damage is about ¼” in depth and usually goes around the area of the stainless steel areas that have been repaired in the past. The cavitation diminishes as it approaches the leading edge of the blade. The wicket gate packing on Unit 2 is the original packing, approximately 25 years old and is in need of replacement to prevent the risk of an extended unit outage. Unit 1 packing was replaced in 1997.

Solution: Repair the cavitated areas around the previously repaired stainless steel areas and replace the wicket gate packing with new Teflon packing.

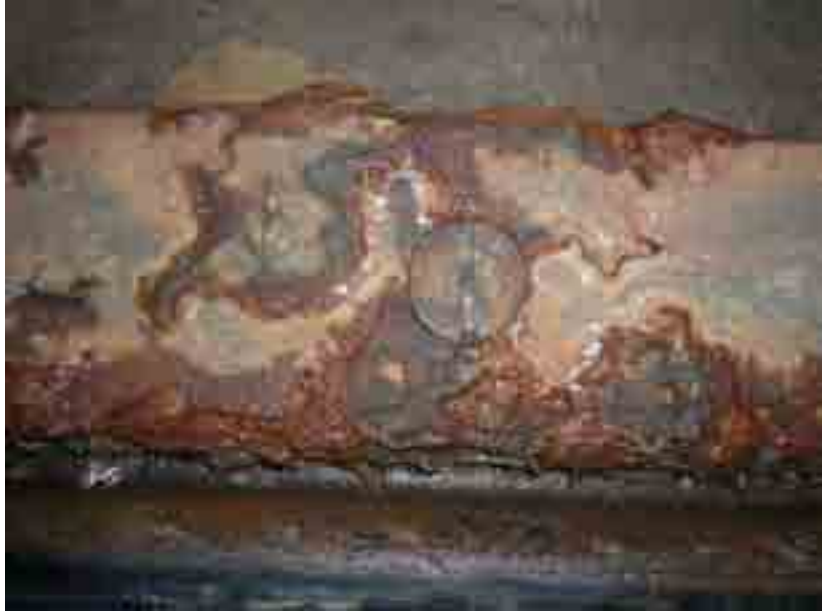
History of Outages/Deficiency: The intake and draft tube gates are the original equipment and will not be rehabilitated as part of the Ozark Major Rehabilitation. Recent HSS inspections indicate the need for immediate refurbishment to include repair of structural members, selected roller chain replacement, side seals, new flapper valve/piping, and painting to prevent further damage. Failure of a roller chain could result in an extended outage at the plant. Existing Paint is Vinyl. Ozark Major Rehabilitation Contract is currently underway, and failure of an inspection of a draft tube of intake gate by structural engineers could result in impacts to the turbine replacement contract.

Solution: Replace intake chains for one gate (the other four have already been replaced), paint old gates, and repair damaged structural members. Install new side seals.

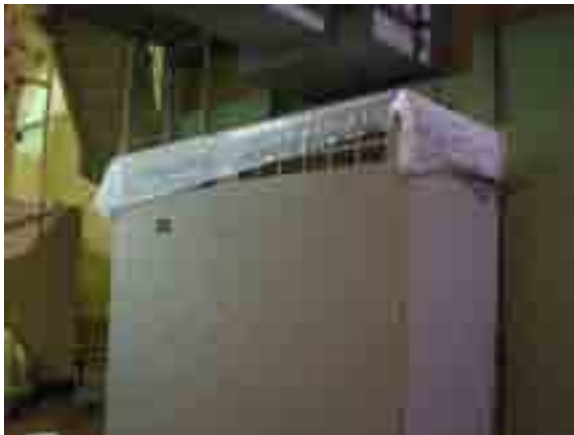
Rain Leaking on Electrical Grounding Cubical

- o Water is leaking through the roof onto the generating units.

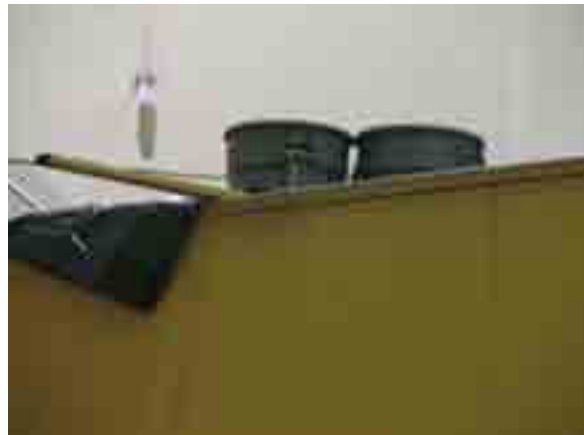
Rain Leaking on Generator Housing

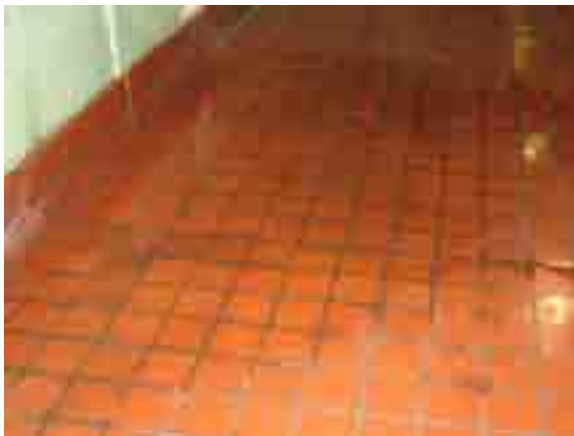
Rain Leakage on Floor

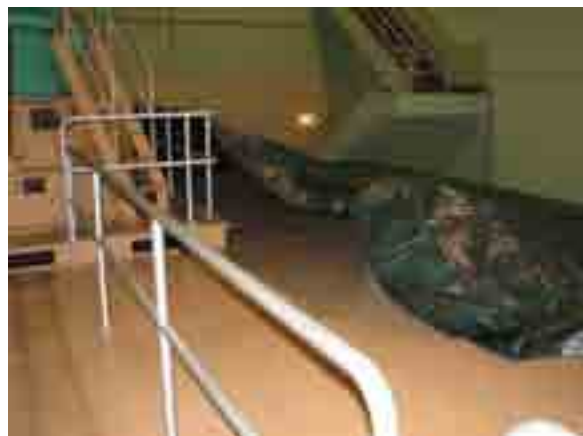
Rain Leaking on Generator Housing

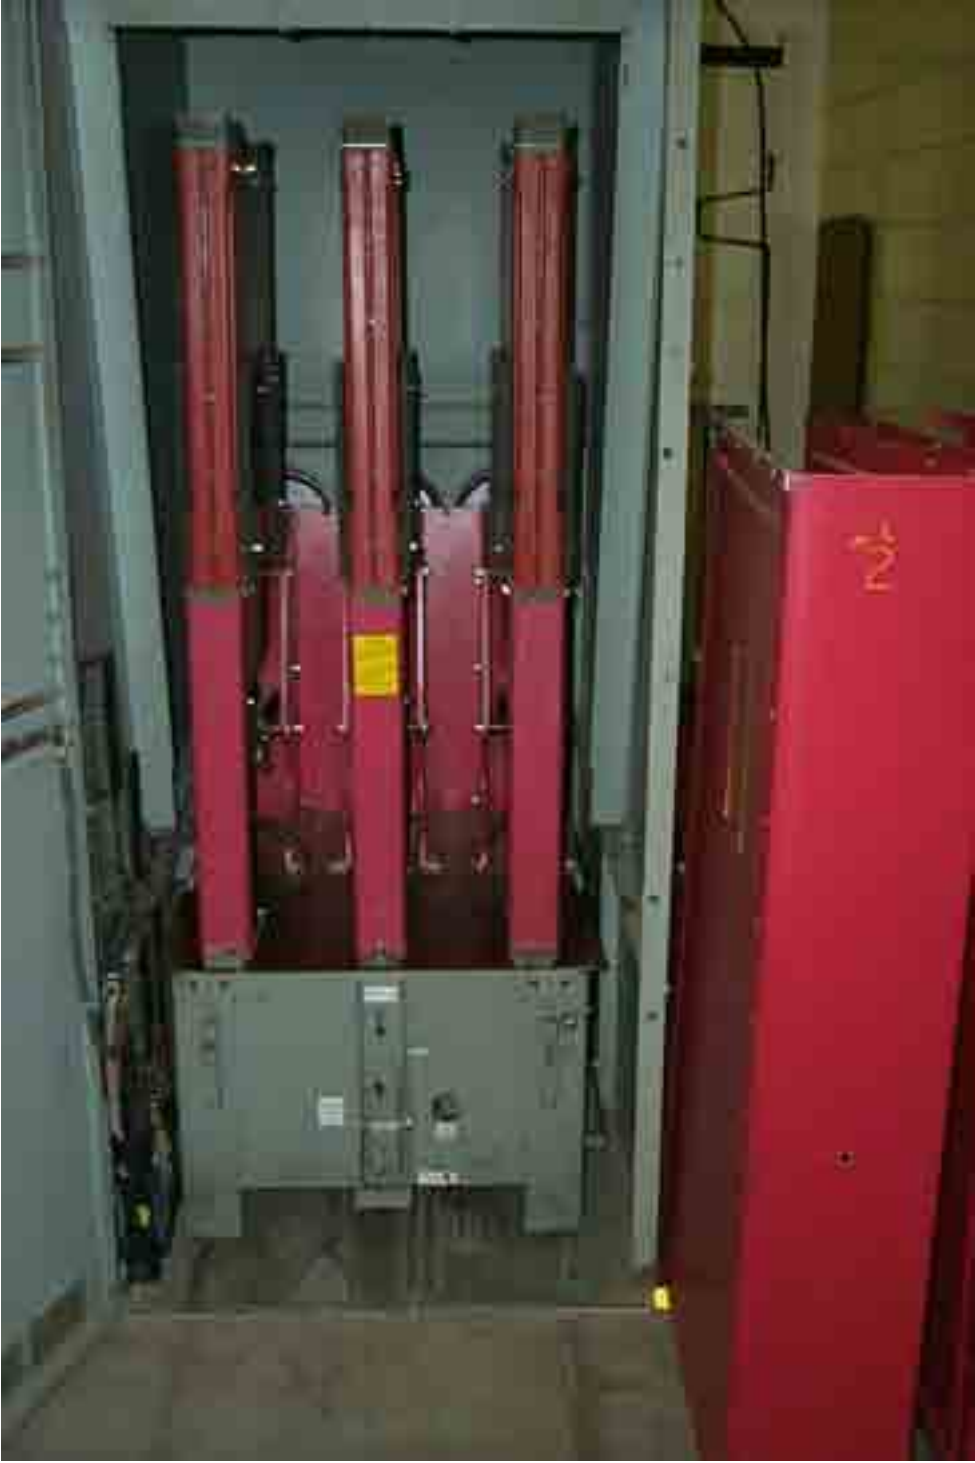
Breaker Element

- o Major damage to the generating units is possible if breakers fail to operate timely in response to sudden failure.
- o An extended outage of one month is possible to repair or replace damage equipment.
- o Reduced circuit breaker maintenance required for new vacuum bottle circuit breakers. Existing breakers continue to be problematic because of atmospheric moisture contamination of the arc chutes.
- o Existing station service breakers are marginally rated for the existing duty.

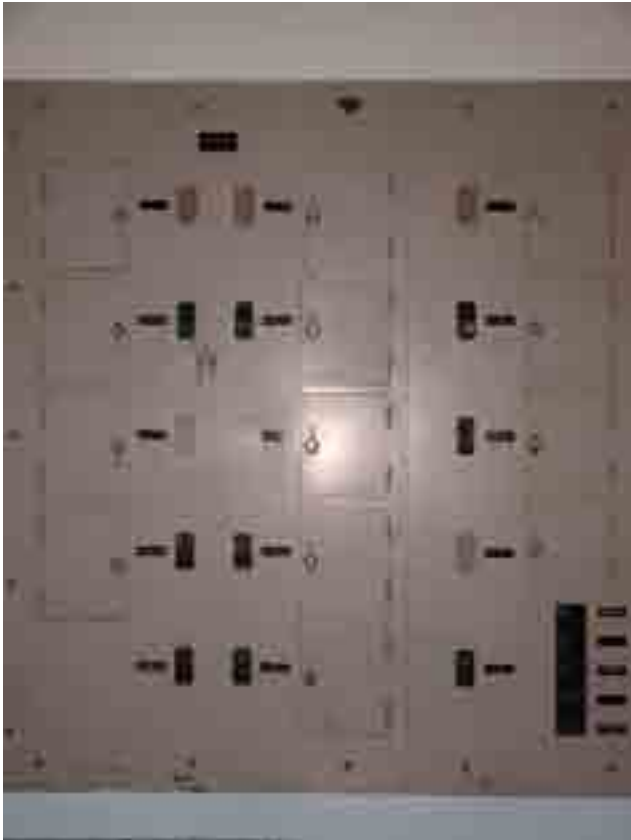
Denison Wall Mounted MCC

- The existing MCCs are underrated and pose a hazard to powerhouse equipment.
- The existing MCCs are obsolete and cannot be properly maintained due to unavailability of spare parts.
- The existing air compressors are original equipment and require more maintenance than the modern design screw type.

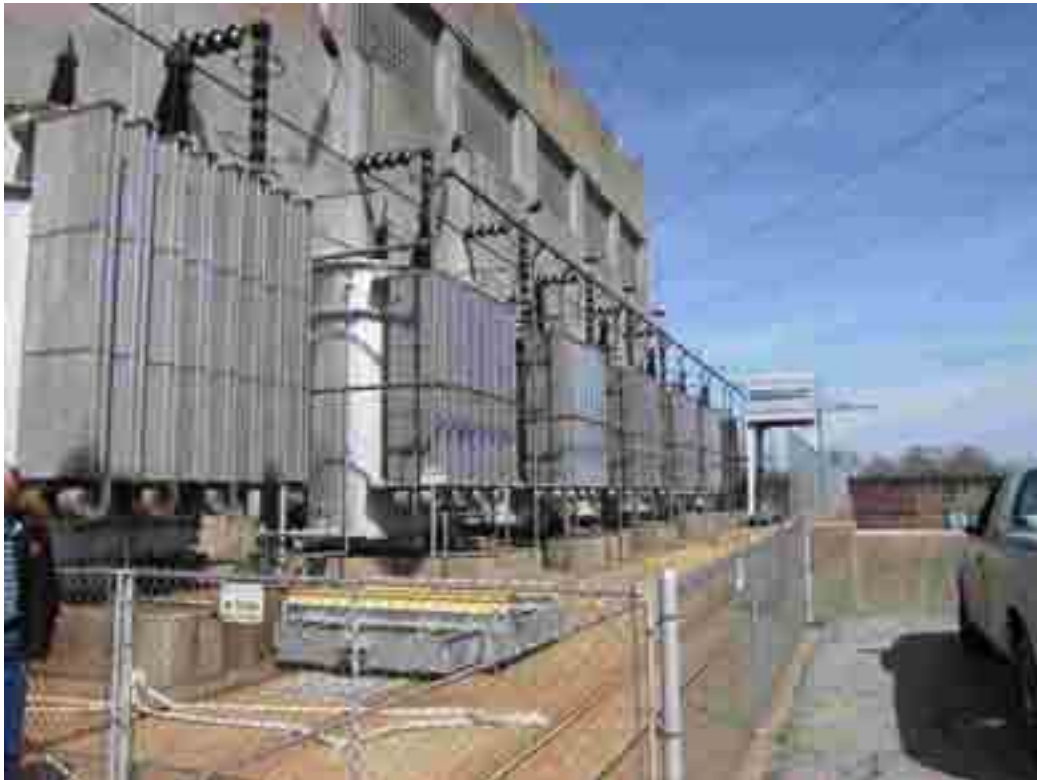
Denison Main Power Transformers

- o Replacement of the turbine will provide more efficient use of the water and increase capacity of powerhouse.
- o If the turbine and wicket gates are not replaced, the existing wicket gates will have to be repaired resulting in significant down time and cost for no efficiency gains or capacity increase.
- o Failure of two or more of the main power transformers would involve a unit outage of an estimated nine months. The transformers have been in service 65 years and have significantly exceeded their service life.
- o Installation of oil containment is impracticable while the transformers are located on the tailrace deck.
